(Updated) Notice Regarding Receipt of the Investigation Report from a Special Investigation Committee

Investigation Report

Summary Version

For Nikkiso Co., Ltd.

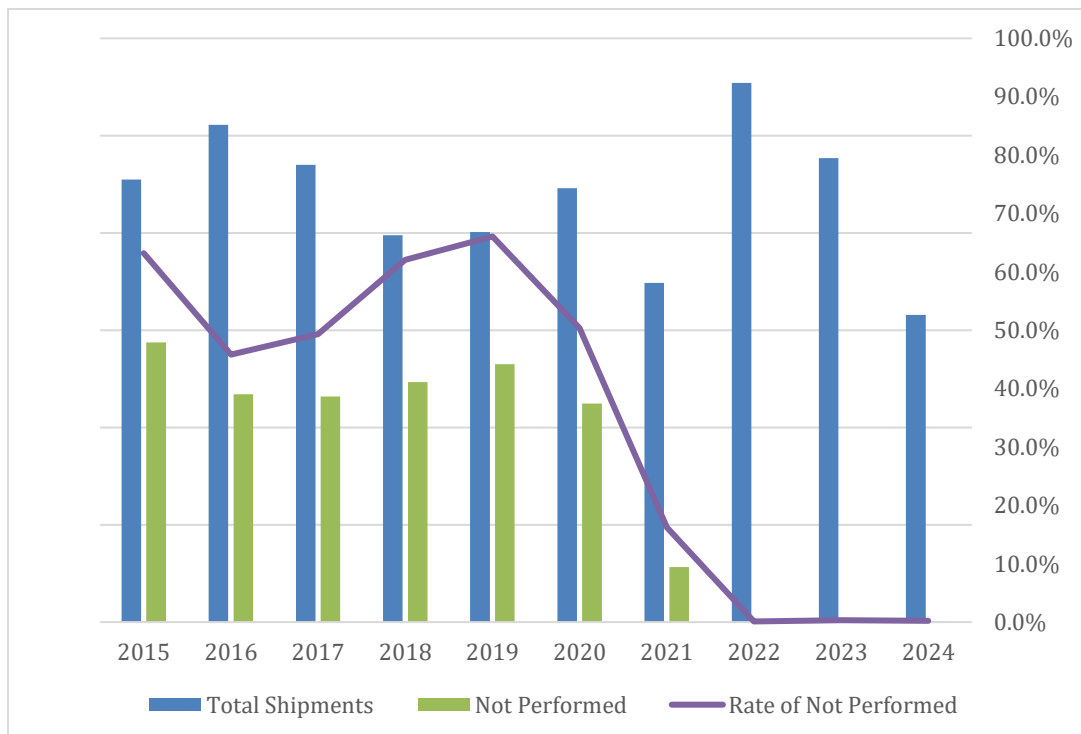
Transition in the Implementation of Water Pressure Tests for NonSeal Pumps (by Year of Shipment)

The transition in the implementation status of water pressure tests for NonSeal Pumps by year of shipment for the past ten years is shown in the figure below. Although there were still a few pumps identified as untested even after the corrective measures in 2021, these were regarded as likely unintentional errors. Furthermore, under the decision-making flow for determining whether tests were performed, some pumps lacked definitive evidence to prove the test had been carried out and thus were classified as untested.

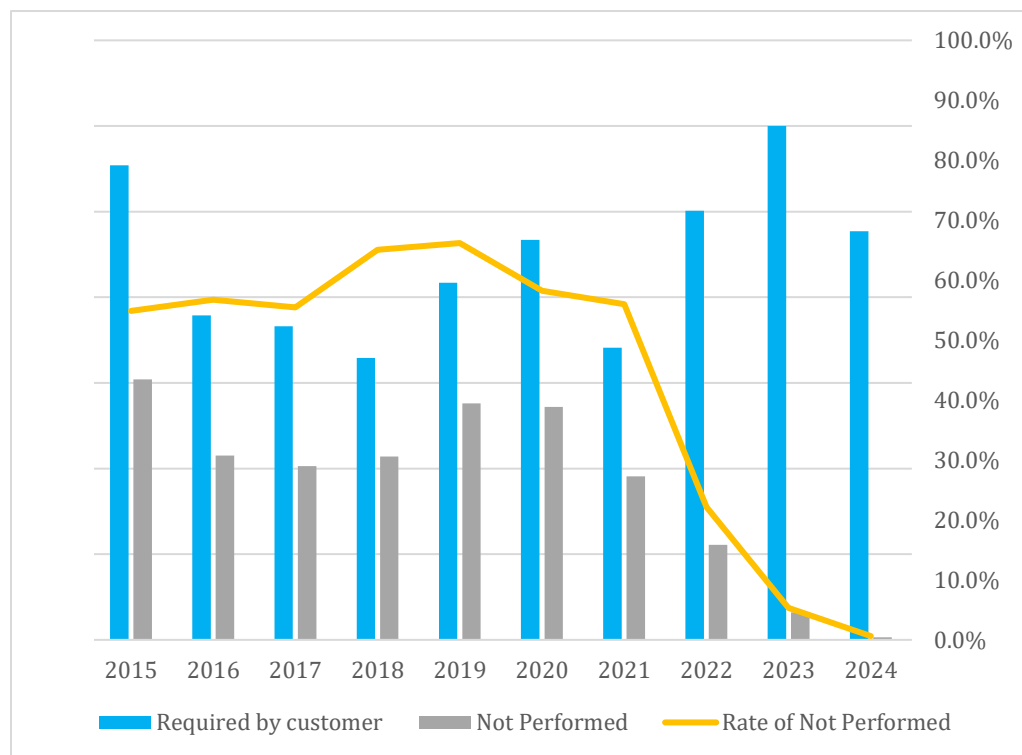
Transition in the Implementation of Airtightness Tests for NonSeal Pumps (by Year of Shipment)

The non-performance of airtightness tests continued until around 2021; however, the personnel in charge of the pre-shipment airtightness section of the Manufacturing Department at that time considered the procedures handed down from their predecessors to be error prone. From the perspective of improving operational efficiency, they adopted a method of determining the testing conditions for each pump based on the inspection work item list available on the Company's internal website. Between the second half of 2021 and 2022, work instructions related to this operation were created.

As a result of these efforts, from 2021 onward, the number of cases of partial non-performance of airtightness tests has significantly decreased.

It should be noted that even after 2022, a certain percentage of airtightness tests continued to be partially omitted. From 2022 to 2023, the above-mentioned method for determining testing requirements was not thoroughly communicated, and in cases where other Manufacturing Department employees conducted the pre-shipment airtightness test in the absence of the regular pre-shipment airtightness test personnel, they could not accurately interpret whether customer-specific airtightness tests were required or determine the correct test conditions. These omissions were determined not to be intentional deviations.

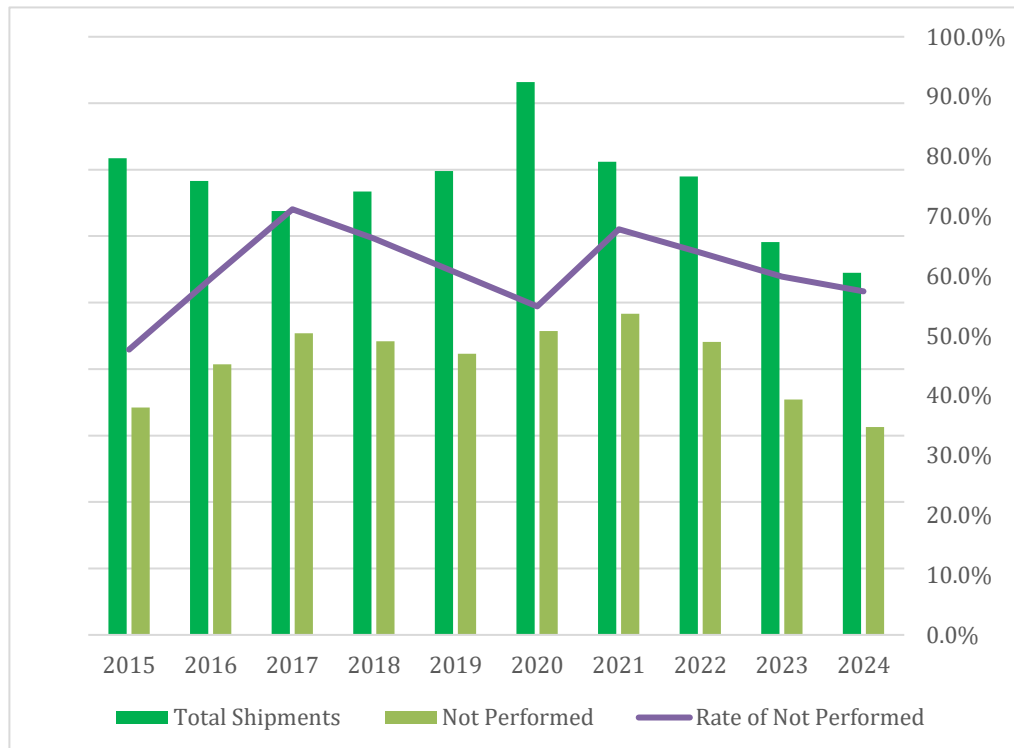
Transition of Water Pressure Testing Implementation for Milflo Pumps (by Shipment Year)

The transition in the implementation status of water pressure tests for Milflo Pumps over the past ten years, by year of shipment, is shown in the figure below.

Subsequently, the SCM Department Production Management Group became preoccupied with preparations for the relocation of the production base to the Miyazaki Plant in June of the same year, and discussions on implementing full water pressure testing were abandoned. Even after the relocation to the Miyazaki Plant, discussions on implementing full water pressure testing were not resumed because priority was given to addressing disruptions in the manufacturing site caused by the relocation, delays in delivery schedules, and related issues. As a result, partial omissions in water pressure testing continued without resolution, and the number and rate of untested pumps did not decrease after 2021, continuing until the Incident was discovered in October 2024.

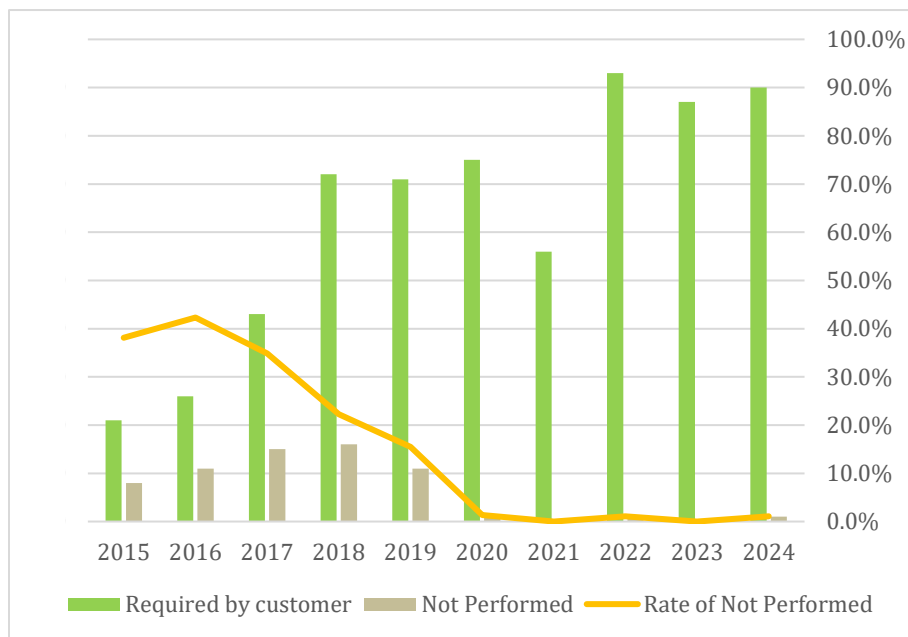
Transition of Airtightness Test Implementation Status for Milflo Pumps (by Shipment Year)

that omitted airtightness tests for certain pumps requiring them, leading to the partial omission of airtightness tests.

The number of omitted airtightness tests for Milflo Pumps has remained very low since 2020 and is generally considered to have improved. Following the Investigation, a mechanism was introduced requiring employees from the Manufacturing Department, the Quality Control Department, and the Production Management Department to secure time each morning to share manufacturing progress, discuss production control, and mutually confirm whether pumps under production require airtightness testing as requested by customers, to prevent any omissions of airtightness testing, including human error.
