(Updated) Notice Regarding Receipt of the Investigation Report from a Special Investigation Committee

Investigation Report

Summary Version

For Nikkiso Co., Ltd.

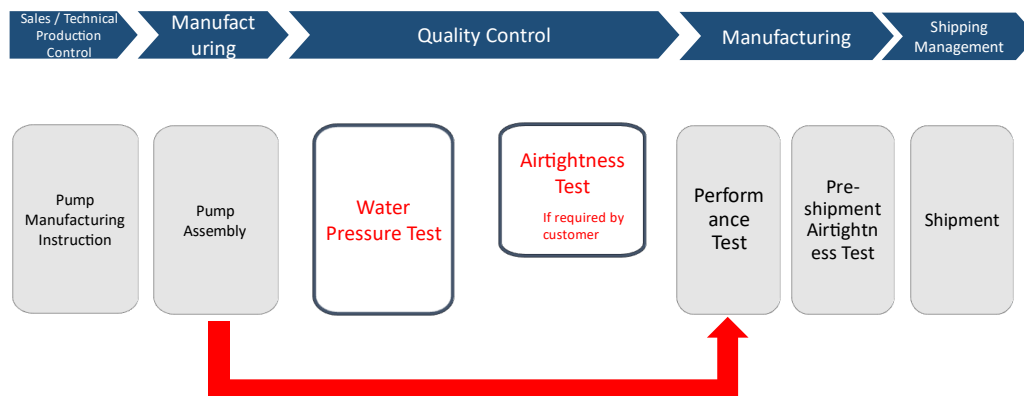
(2) Standard Workflow

The process flow for conducting the water pressure test and the airtightness test within the standard workflow and manufacturing process for NonSeal Pumps at the Company is shown in the figure below.

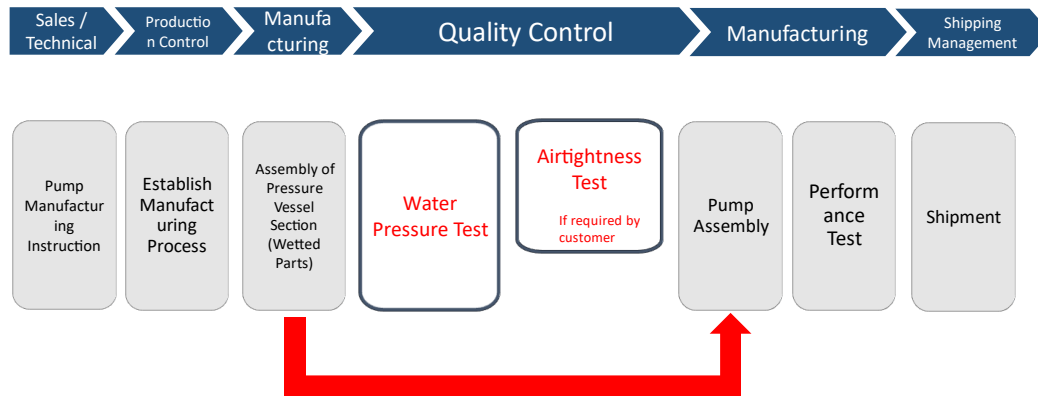
(2) Standard Workflow

The process flow for conducting the water pressure test and the airtightness test within the standard manufacturing process for Milflo Pumps at the Company is shown in the figure below. In cases where these tests were not performed, as indicated by the red arrows in the figure, the pumps were not brought to the Quality Control Department after the assembly of the pressure vessel section (wetted parts) by the Manufacturing Department, but instead proceeded directly to the next process, pump assembly, which was conducted by the Manufacturing Department.
